TQB Brands Pty Ltd

TQB Brands Motorcycle Lift Pump Bleeding Procedure

Product Code: 2103T

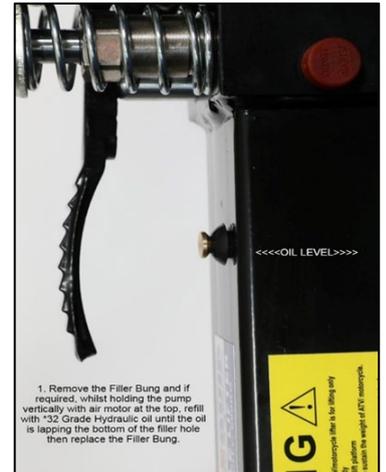
Fault Description: The usual symptoms of a 2103T motorcycle lift pump with air in the system are as follows.

- No resistance in the pump stroke while pumping up a load [pedal feels light].
- Most of the down stroke of the pump taken up but no movement of the Lift ram.
- Lift Ram jumps upwards while being pumped up.

1. Remove the Filler Bung and if required, whilst holding the pump vertically with air motor at the top, refill with *32 Grade Hydraulic oil until the oil is lapping the bottom of the filler hole then replace the Filler Bung.
