TQB Brands Pty Ltd

# TQB Brands Floor Type Trolley Jack Bleeding Procedure

Product Code: 2906T

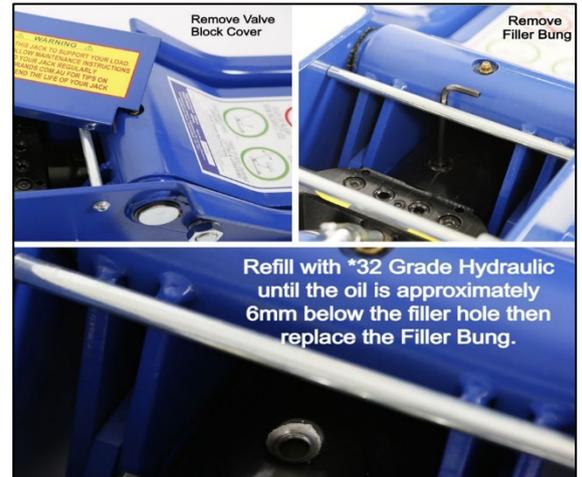
Fault Description: The usual symptoms of a trolley jack with air in the system are as follows.

- No resistance in the pump stroke while raising up a load [handle feels light].
- Most of the down stroke of the pump handle taken up but no movement of the Lift ram.
- Pump handle slowly raises on its own while lift arm lowers.

1. Remove the Filler Bung and if required, refill with \*32 Grade Hydraulic until the oil is approximately 6mm below the filler hole then replace the Filler Bung
